Report no.	18.00120-1 Rev A This report replaces 18.00120-1 dated 26-09-2018	bezoekadres Poppenbouwing 56 4191 NZ Geldermalsen postadres Postbus 202 4190 CE Geldermalsen
Test date Report date	9 April and 25 September 2018 23 October 2018	T +31 (0)88 244 01 00 F +31 (0)88 244 01 01 E info@skgikob.nl I www.skgikob.nl
Applicant	B&B Locks BVBA	
	Uilenbaan 88, unit 3 B-2160 / Wommelgem Belgium	TESTING RvA L 406
Size report	This report consists of 15 pages	Notified Body NB 0957 NB 0960
Subject	Testing of strength aspects of locks and latches according to EN 12209:2003 +AC:2005 of locks type: G1 and G1M	
Laboratory technician	J.G. van de Wetering	
Technical Manager	dr. ir. A. van Beek

SKG-IKOB was commissioned by B&B Locks BVBA – Wommelgem (Belgium) to perform a test on strength aspects according to EN 12209:2003 +AC:2005 (hereafter referred to as EN 12209) on:

Locks and Keepers of types: G1 and G1M

Type designation: G1 and G1M

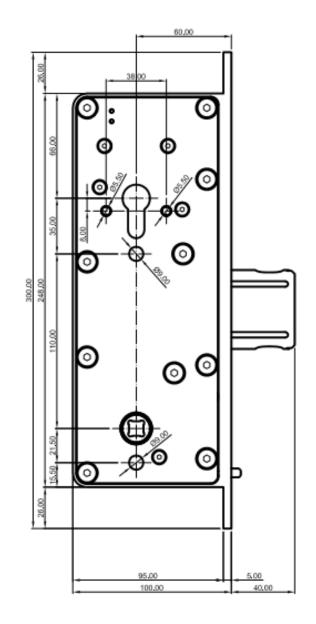
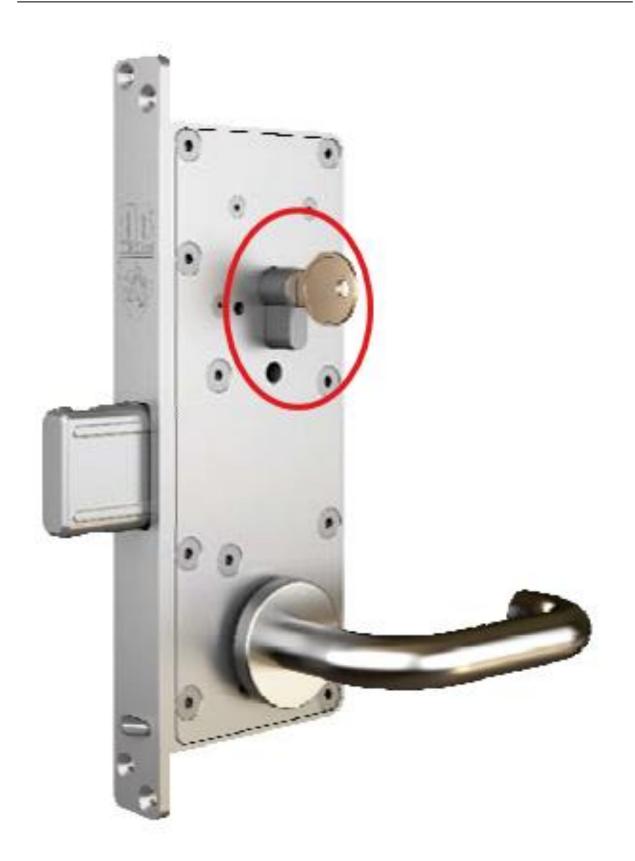
G1M lock

Description: G1: Mechanical lock with electromechanical lock case G1M: Mechanical lock with locking plate.

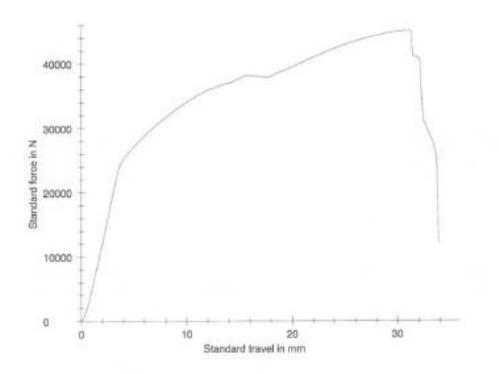
G1

: hoofdschoot wordt uit slotkast getrokken bij Fmax. voorplaat slotkast vervormt.

Nr	Maximum Force N	Travel at Max. Force	Time at Max. Force 8
1	45250,81	30,90	394,42

Test	model
1. End load dead bolt	(G1M)
2. Pull load i.c.w. lock case	(G1)
Side load on deadbolt	(G1M)

achieved value 59,0 kN 45,2 kN 100 kN (supported)

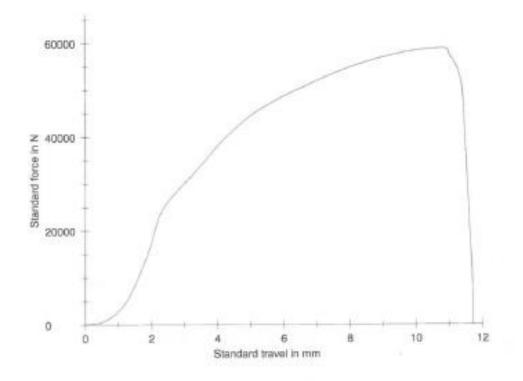
: schoot wordt door de vergrendeling gedrukt bij Fmax.

Nr	Maximum Force N	Travel at Max. Force	Time at Max, Force
1	59084,54	10,84	509,41

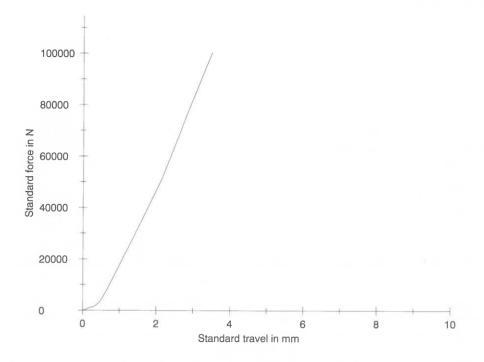
G1M

: SLot nog intact en functioneel bij Fmax. supported getest op 3 mm

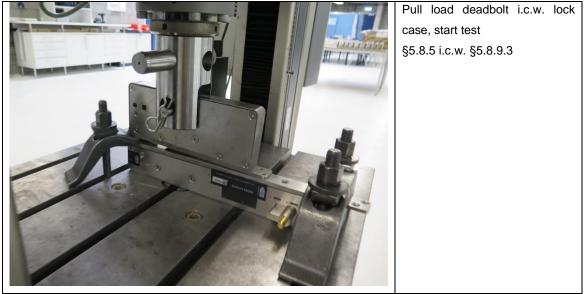
Pull load deadbolt i.c.w. lock case, after test §5.8.5 i.c.w. §5.8.9.3
	Pull load deadbolt i.c.w. lock case, after test §5.8.5 i.c.w. §5.8.9.3
<image/>	Side load deadbolt i.c.w. lock case, start §5.8.2.1 i.c.w. §5.8.9.2

Test April 2018 1. End load dead bolt (G1M)	paragraph §5.8.4.1
2. Pull load in combination with lock case (G1)	§5.8.5 i.c.w. §5.8.9.3
Test September 2018 3. Side load on the deadbolt (G1M)	§5.8.2.1 (supported)

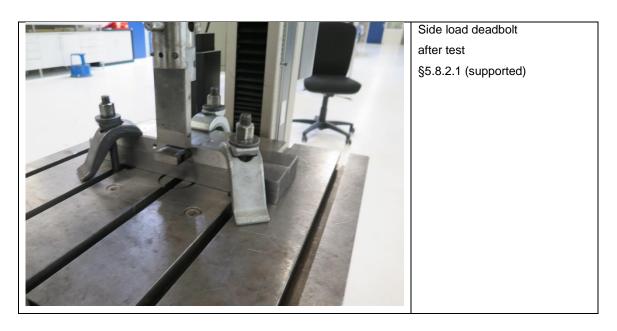
Side load deadbolt i.c.w.
lock case, start
§5.8.2.1 i.c.w. §5.8.9.2
Side load deadbolt i.c.w.
lock case, after test
§5.8.2.1 i.c.w. §5.8.9.2
Side load deadbolt
start
§5.8.2.1 (supported)
